# Manhole Inspection Summary

Manhole # S45C\_\_024MH

Insp Date: **8/18/08 11:27 AM**

**Location** Address: **FAIRMONT**

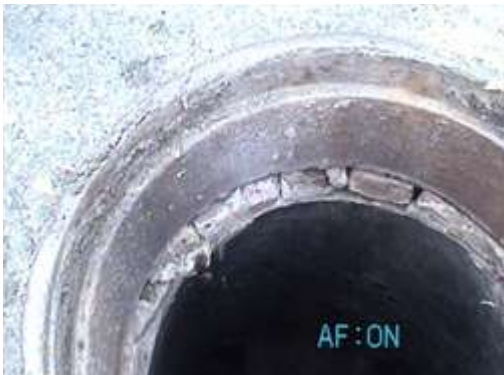
Defect 2

Condition: ☐ Sound ☐ Cracked ☐ Root Intrusion ☒ **Loose Brick** ☐ Deteriorated

Loose brick

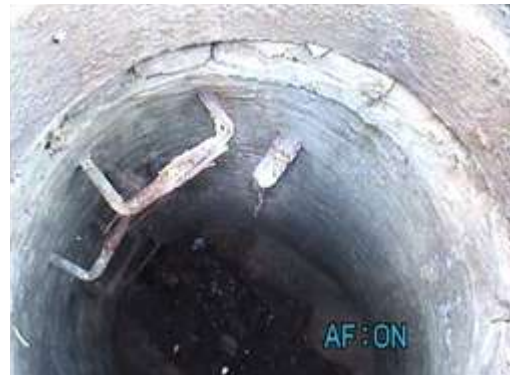
Defect 1

☒ **Leaks**

Frame leaks

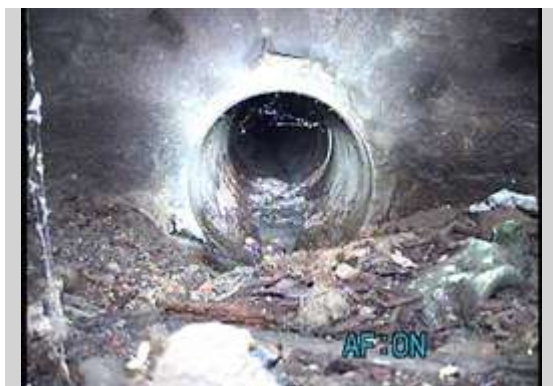
12 O'Clock Outflow

8 in. Circular Gravity Sewer  
Pipe Out @ 12 O'Clock

Deposits: ☐ None ☐ Mud ☐ Sludge ☒ **Debris** ☐ Grease

Silt Depth: **0.15** (in.) Deposits Extent: **Light**
